HISTORIC PROJECT

CLAPHAM COMMON BANDSTAND

London

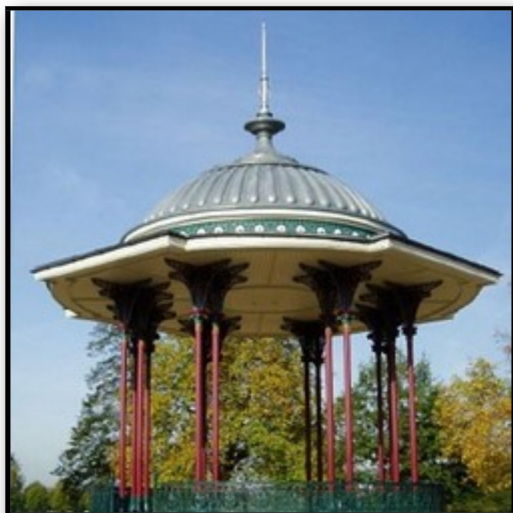
The restored bandstand (Photo: Tristan Forward : Creative Commons Licence)

Such was the state of the bandstand that in 1997 English Heritage placed it on its Buildings at Risk register. Thanks to a collaboration between the local community, Lambeth Council and the National Lottery it has now thankfully been restored to its former glory. The failed zinc roofing has been replaced, the finial remade to original designs, the concrete deck replaced and finished with timber decking, and the brick piers in the basement repaired. Many other repairs and improvements have been made, including a new stone ramp for easier access. The surrounding area, was also improved, including providing new toilets at the nearby cafe and upgrading lighting.

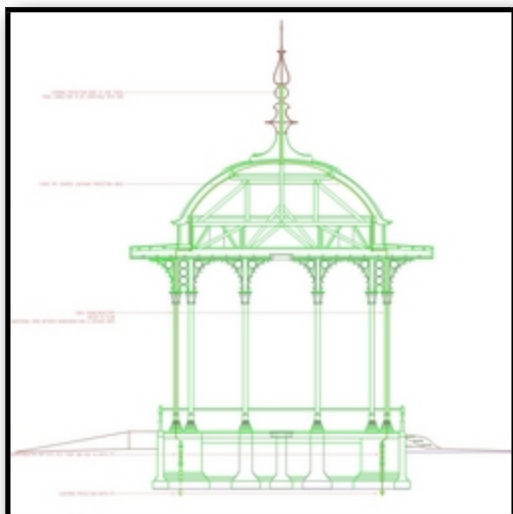
Drawing of the bandstand. Lightning protection runs down a disused rainwater pipe within one of the columns

New drainage was laid around the bandstand—ingeniously one of each pair of support columns acts as a rainwater downpipe; these were cleaned and relined. Lightning protection runs down two unused downpipes from the finial above to earth pits. Another of these columns was utilised to run electrical services up to the roof void. Lighting was kept discrete and practical.
